European Refuse Fired Energy Systems: Evaluation of Design Practices. Volume XVI: Duesseldorf-Flingern Plant, West Germany

Duesseldorf-Flingern Plant
West Germany

This trip report (SW-176c.16) describes work performed for the Office of Solid Waste under contract no. 68-01-4376 and is reproduced as received from the contractor. The findings should be attributed to the contractor and not to the Office of Solid Waste

Volume 16

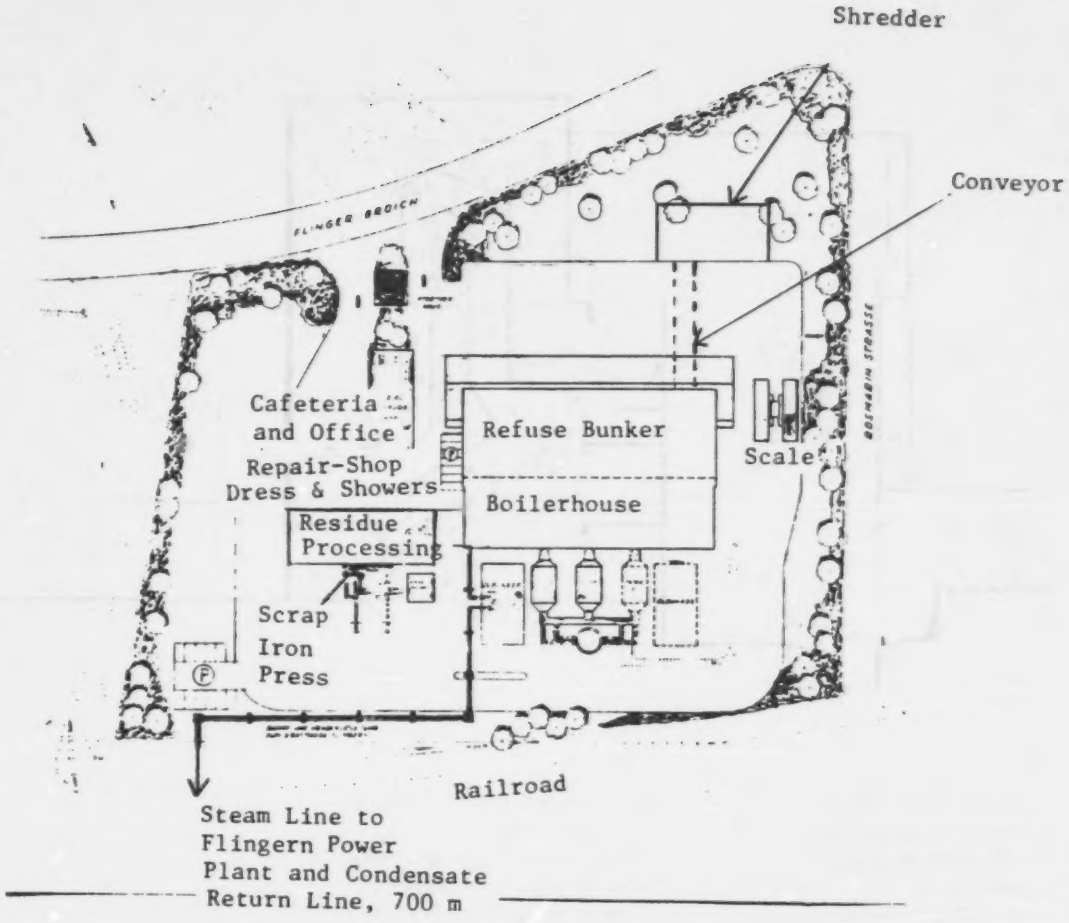
Figure 3-3 shows the plant property which is located in a concentrated industrial area well inside the city.

The weigh scale is to the right of Figure 3-3. Two scales are provided--one on each side of the scale building--so that two trucks can be weighed simultaneously. The scales were built by Schenck of Darmstadt. Normally there is one scale operator. At peak times, there are two. Peak times are from 8:30 a.m. to 10:30 a.m., 12:00 to 1:30 p.m., and 2:30 p.m. to 3:00 p.m.

FIGURE 3-3. PLAN OF DUESSELDORF WASTE-TO-ENERGY PLANT (COURTESY STADTWERKE DUESSELDORF)

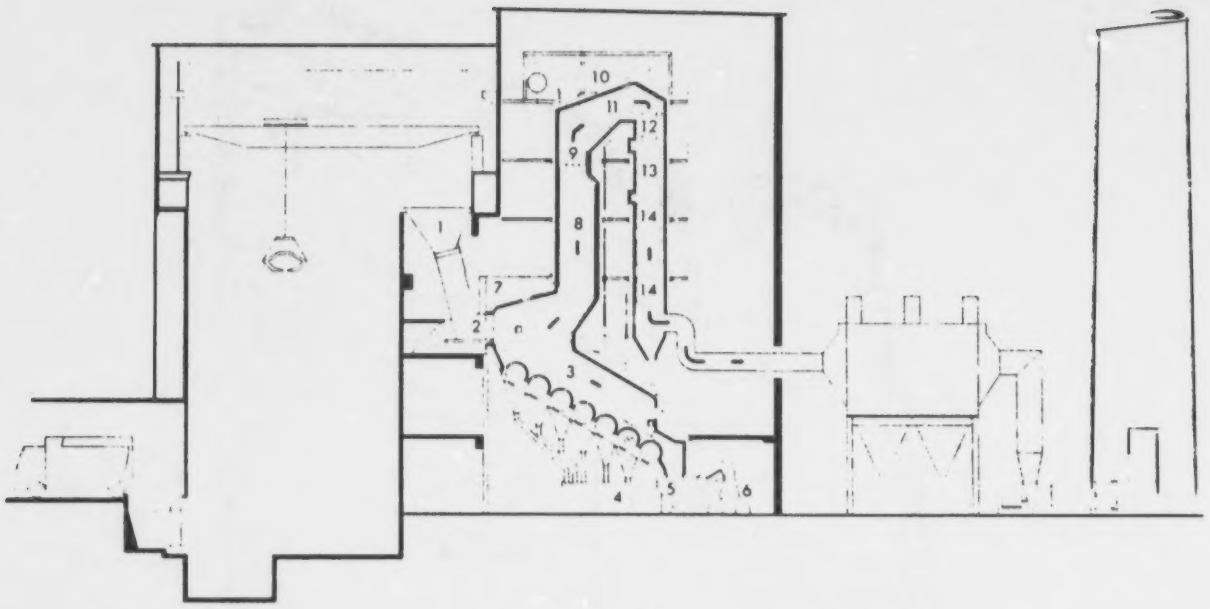
Figure 3-4 shows a cross-section of the plant as it was built in 1965.

FIGURE 3-4. CROSS SECTION OF DUESSELDORF PLANT (Units 1-4)
(COURTESY VEREINIGTE KESSELWERKE)

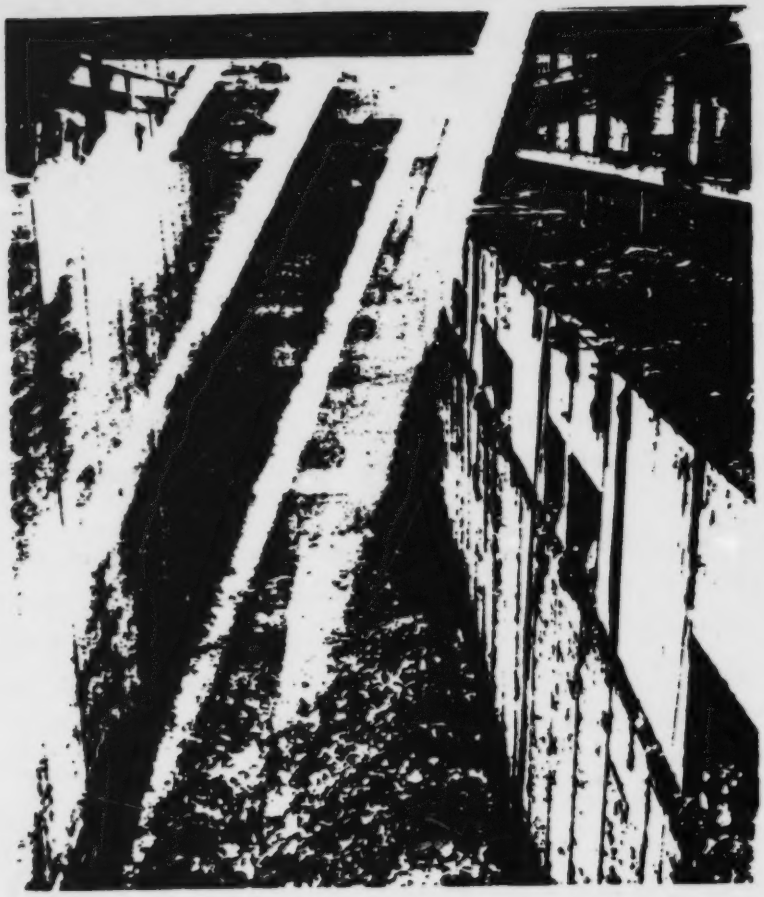
There are three „Schiess" cranes (now part of Demag), 120 tonnes or (132 tons) each. One crane is stored as a spare on a track in a loft above the boiler top level. Also, the crane can be quickly hoisted onto this storage track for repairs. One of the two crane operator's posts can be seen on the left in Figure 3-5. Both cranes operate simultaneously during the day, alternately at night.

FIGURE 3-5. MAIN STORAGE PIT. THERE ARE TWO CRANE OPERATORS OPERATING PULPIT FOR ONE IS AT UPPER LEFT (Courtesy Vereinigte Kesselwerke AG)

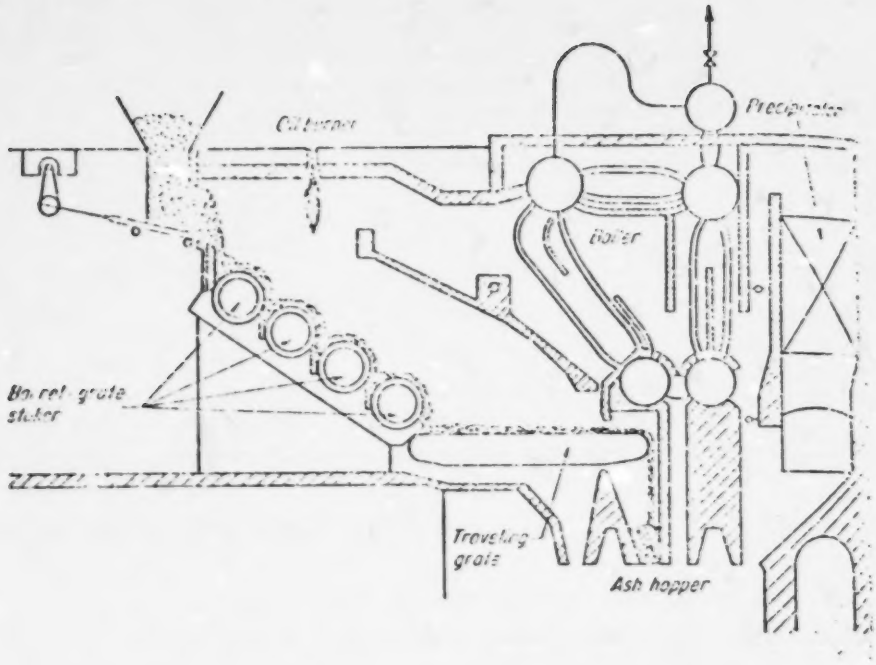
FIGURE 3-8. FIRST TEST INSTALLATION OF REFUSE ON BARREL GRATE ADDED TO EXISTING COAL-BURNING TRAVELING GRATE AT FLINGERN POWER PLANT

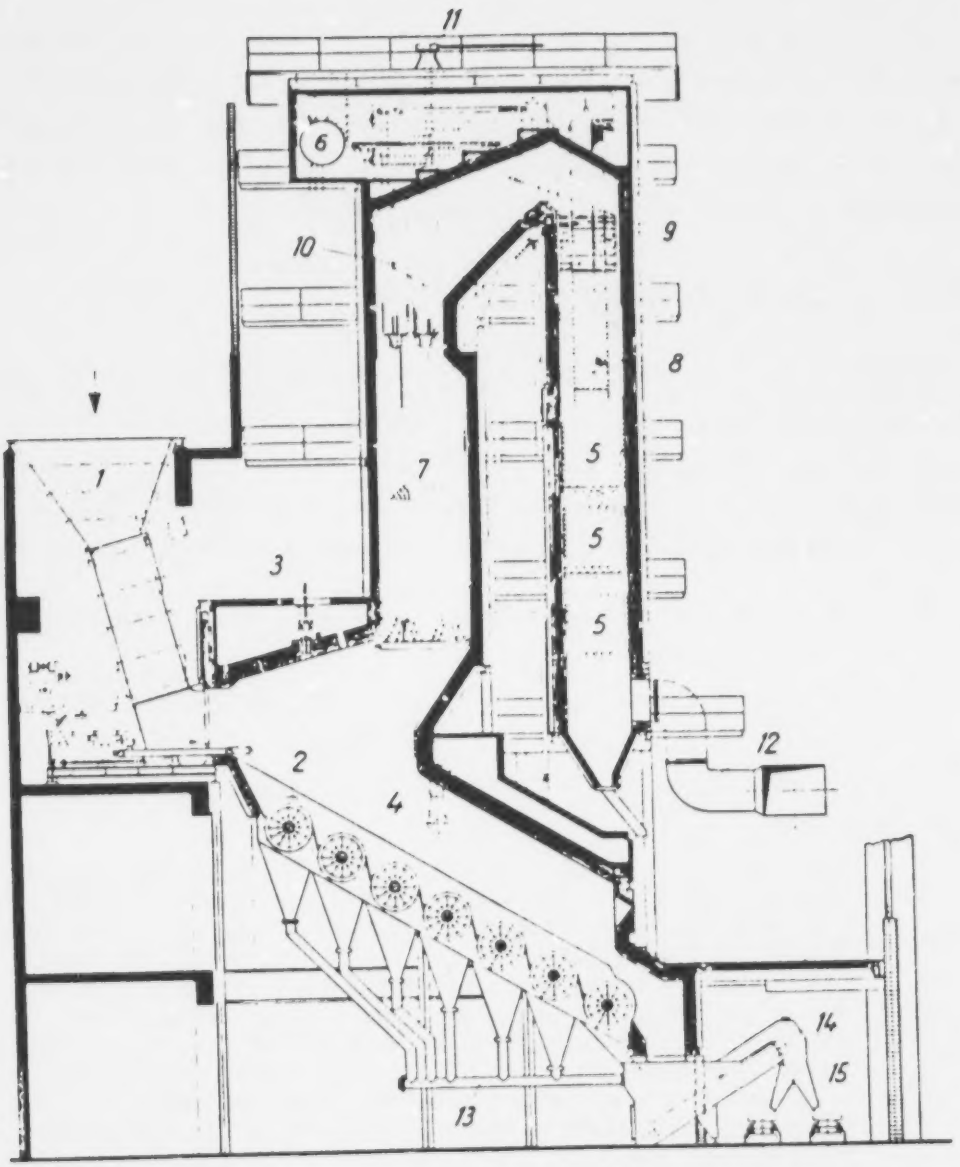
FIGURE 3-9. CROSS SECTION OF ONE OF BOILERS NO. 1-4 (COURTESY OF STADTREINUNGS UND FUHRAMT DUESSELDORF)

> "For different reasons, among others' economy, the construction and operation of large incinerator plants in Germany has been put into the hands of municipal power plants or similar institutions. This had the result that in the design of the incinerator plants, the same design elements have been used as in the design of coal-fired power plant steam boilers. For example, to save construction costs and volume, the incinerator steam generator was built directly on top of the furnace, instead of separating the furnace from the so-called waste heat boiler as practiced in former times. In addition, it was desired to utilize the steam for power generation and district heating. Therefore, the steam conditions were matched to those of the power plants.
>
> In 1967, after tube failures had been reported at other incinerator plants, in Dusseldorf the tubes just above the furnace were inspected and at the lower area of the side walls, the first indications of corrosion were found (Figure 3-9).

> As a means of protection, additional secondary air nozzles were installed to build up a curtain of excess air in front of the tubes. Furthermore, the endangered area was studded and covered with a 1/2-inch layer of silicon carbide refractory. In other plants, this method of protection already has been applied, with similar good results.
>
> In 1968, a tube rupture occurred in one of our boilers. The cause was investigated and found to be corrosion by the flue gas. Subsequent extensive inspections of the boilers demonstrated that corrosion observed the year before had continued and reached the tube surface above the protected area (Location 3). Not only the side walls but now the front wall was affected. Ultrasonic measurements showed that it was necessary to renew about 30 to 40 tubes in each boiler for a length of about 7 feet. A considerable number of the remaining tubes had to be reinforced by welding. Moreover, an extended area of tube surface was studded and concealed."

In all boilers at this plant, the high-temperature section of superheater is a suspended platen type located at the top of the first open boiler pass as shown in Figures 3-9 and 3-10. Experience at many plants has indicated that it would be desirable to position the superheater at a greater distance from the main furnace. For one thing, the gas cooling rate is relatively slow as it rises in the first open pass toward the superheater. Thus, if there are frequent bursts of high temperature gas leaving the furnace because of the inhomogeneity of the refuse causing erratic burning, there are then likely to be moments of excessive gas temperature

"In the time from 1970 to 1972, fireside qorrosions of a considerable rate appeared on the final state platen superheaters on Boilers No. 1-4, which are installed at the upper end of the first flue. The tube side, being directed against the gas flow, showed a rapid material wastage at a rate up to $4,5 \times 10^{-6}$ m/h (0.00018 in/hr). At first, this corrosion was interpreted as chlorine corrosion under lack of oxygen. Gas analyses, however, showed, that in these parts of the boiler, sufficient oxygen is present at any time. Only extensive analyses of the deposits of the tubes have shown a chlorine-corrosion released by the transformation of alkalichlorides into sulphates within the deposits. As a partial remedy, the endangered tube parts were provided with protective shields in form of flat steel. This proved to be sufficient, but as these steel bars are cooled insufficiently, an inspection and eventually a partial renewal has to be made at every shut-down of the boiler, approximately every 3 months. To cut down the maintenance costs, another tube material was sought for better resistance against this corrosion. This is an austenitic steel which has the German standard specification:

In 1972, platens of this material were installed. On occasion of a boiler inspection, after 16,000 hr, no substantial material wastage could be found. But lately (1976), the first failure of these platen tubes happened. The loss of material is strictly limited to the outside surface of the 90° bend of the U-shaped tube. The horizontal and vertical parts of the tubes are completely unharmed. By the appearance of this damage, it can perhaps be concluded that by bending the tubes not only a reduction of the thickness of the outer wall occurs, but a structural change of the material occurs too, which makes it sensitive to corrosion. Tests about this matter are running, but not yet concluded, so that final statements cannot be made. In relation to the corrosion rate of 1970, these tubes have been a significant improvement, although no protective shields have been used on these tubes.

> "To guarantee a better burn-out and mixture of the flue gases in the existing units, the following changes were accomplished. The overfire secondary air was increased to about 25-30 percent of the total air. But the experience is, that with the overfire air by itself a complete mixture of the gases cannot be obtained. The relatively cold air does not blend with the gas but pushes it aside.
>
> The first step to change the configuration of the furnace was done by the construction of a fire guiding wall. This is an arch-like wall of firebrick, built in at the end of the furnace front-roof. This guiding-wall hinders the direct flow of the gases along the roof into the first flue. Furthermore, it is a contraction of the profile of the furnace throat by which part of the gas with high excess air from the end of the grate is forced into the front part of the furnace. Because the secondary air nozzles are located directly in front of the wall, a better vortical intermixture of air and gas is achieved. The arch-like configuration of the wall contracts the gas flow in the center of the first flue which results in a more uniform directed gas stream.

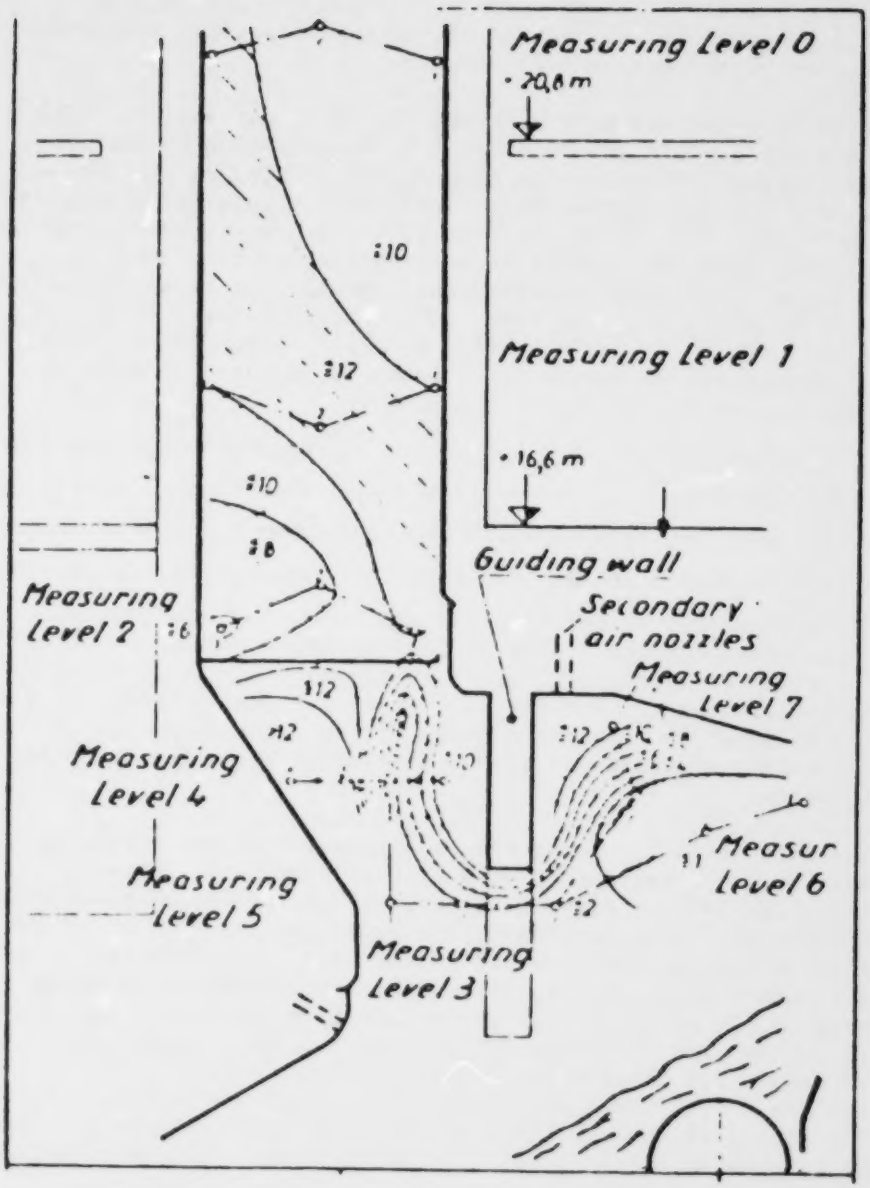
FIGURE 3-10. DIAGRAM OF LOCATION OF GUIDING WALL AT TOP OF FURNACE OUTLET SHOWING EFFECT ON OXYGEN DISTRIBUTION IN GASES

>
> The experience with this guiding-wall is very good. Since its erection in the years 1968 and 1969, tube corrosion in the first pass has not continued or spread out. Stream tests with a water-tank model and extensive gas analyses have proved the efficiency for the uniformity and burn-out of the gases."

This guiding wall in Furnaces 1 through 4 was formed of high alumina content refractory and was not air cooled. Now these are made of silicon carbide. Because of the high temperature to which these refractories are subjected, they are now being air-cooled. Uncooled, their life was about 23,000 hours. The air cooling arrangement is discussed later under "Secondary Air". No. 4 was converted in early 1976, No. 3 in early 1977, and Nos. 1 and 2 will be converted to air cooling later (completed 1978).

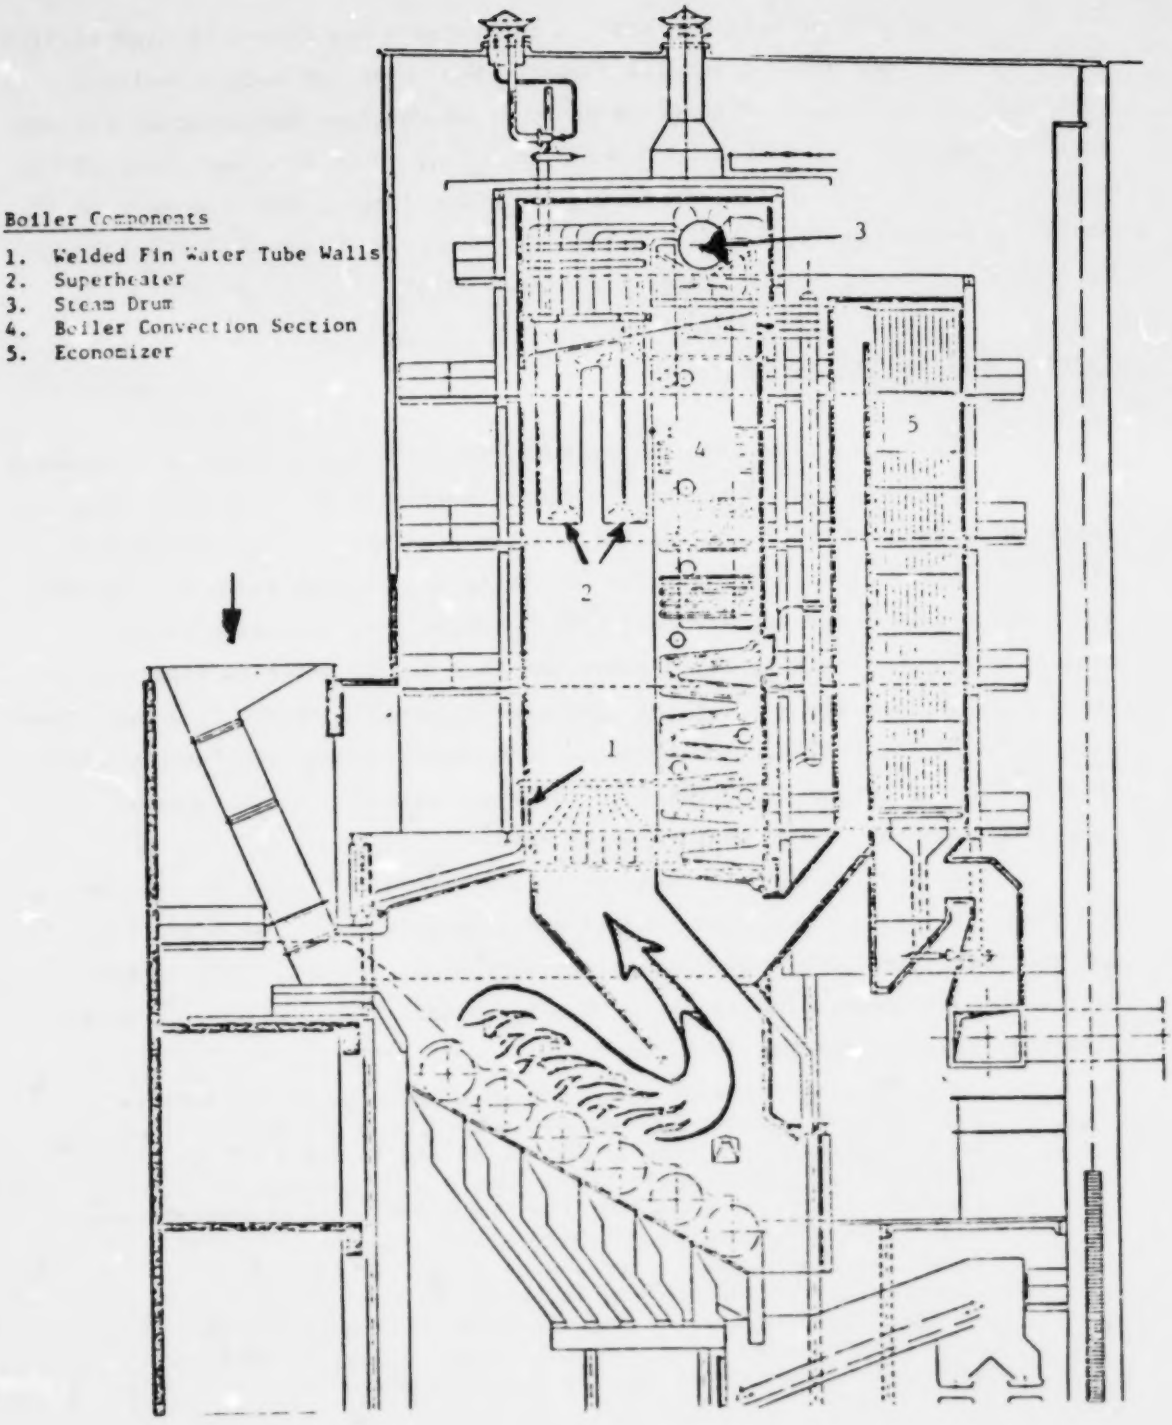
FIGURE 3-11. CROSS SECTION OF BOILER NO. 5 WITH ROLLER GRATE "SYSTEM DUESSELDORF" (Courtesy Stadtwerke Duesseldorf Kraftwerke)

For the sidewalls, the choice between water-walls and uncooled refractory lining was discussed. Water-walls would have solved the problem of slagging, but these tube surfaces need special care and maintenance. To protect them against corrosion and erosion, they must be covered with plastic refractory lining, which must be checked at frequent intervals, and if necessary, be amended. An uncooled lining of the sidewalls was chosen, under consideration that the ignition of refuse with low heating values must be supported. The refractory material, which is most suited is SiC (silicon carbide) on account of its slag repellent property. On the other hand, it is known that the use of SiC materials in furnaces is problematic, when temperatures of 900 C (1650 F) to 1010 C (1850 F) exist and the flue gas contains considerable amounts of O_2 and H_2O. Experience of American operators communicated to the manufacturers of the refractory materials in Germany had indicated unsatisfactory performance. Accordingly, after 6,000 operating hours, the SiC lining of the front part of the furnace was totally damaged. The furnace had to be reconstructed with plastic refractory on an AL_2O_3 base. Now the slagging problem appeared again, and during the following operation period several times heavy slag formation occurred at the side walls, which made it necessary to shut the boiler down and remove the slag. In order to achieve a further undisturbed operation, the combustion was shifted to the end of the grate. Instead of air, recycled flue gas was injected under the first roll of the grate. Due to the oxygen reduction in the forward combustion chamber, the main combustion zone moved one roll downward along the grate. Consequently, the burnout time for the flue gas was shortened, and after an operation time of about 1 year, the first corrosion on the tube surfaces of the front wall of the first pass occurred.

Because of the unsolved problems with the furnace, the endangered area, about 2 m (6.5 ft) in height, was studded and lined with plastic refractory. Later no further corrosion was found in this zone.

Although the corrosions of the wall tubes of the first boiler pass in No. 5 are under control, a totally different picture is presented in the superheater area. Both the final stage superheater and the convection superheater were affected by numerous attacks and damages since startup. The tube failures of the superheaters have been as follows:

- 22 failures of convection superheater tubes (see No. 2 of Figure 3-11)
- 13 failures of final superheater tubes (see No. 3 of Figure 3-11).

An accumulation of that kind of tube failures caused by corrosions has not been observed in former years. The final (suspended platen) superheater which is of nearly the same design and arrangement as in Boilers No. 1-4, had to be renewed in two steps in the years 1973 and 1974. The cause of this failure was a fault in the design. The 14 tubes of each platen superheater had been welded together instead of being clamped. Hereby the tubes were hindered in their expansion so that after a short operation period, they were completely twisted and no longer hung vertical at the leading edge of the tubes, not only the outward tubes were endangered, but the superheater platens presented larger surfaces to the corrosion attack. With the renewal of the first half of this superheater, the first four outer tubes of each platen were made of the same austenitic steel mentioned earlier. But after about 6,000 hours of operation, one of these tubes failed and the others showed considerable attack too. Investigations were made in order to trace the cause of this short tube life, compared to that of the same tubes in the other boilers. A new phenomenon was found not known up to that date. On the presuperheater too, being located at the upper end of the second gas pass as a convection tube bundle, corrosion occurred to an extent not known from the other boilers. Not only the tube bends were affected, but at the middle section of the tube bends, the material was carried away at the top side, the material loss at the middle sections occurred at both sides of the tubes at an angle of about 30° to the vertical axis as a longfaced erosion. In addition, not only the first or second row of the tubes is affected, but the damages continued throughout the whole upper tube bundle."

"By search for the possible reasons of this intensified corrosion, it was found that in 1973 about 1 year after the start of operation of Boiler No. 5 a new situation had come up in the method of operation. In May, 1973, a shredder-installation for bulky refuse (wood of any kind, furniture, boxes, crates, etc.) was started.

Mr. Thoemen believes this is caused by a concentration of potassium chloride in the tube deposits.

- Good mixing of refuse to avoid concentration of corrosive salts in one boiler
- Clamp protective metallic shields on tubes at vulnerable locations. He finds that a convenient alloy for this purpose(similar to 1.0% Mn) Sicromal 8 plus because it can be formed and welded is:
  - Carbon: 0.1%
  - Silicon: 1.0%
  - Aluminum: 0.8%
  - Manganese: 1.0%
  - Chromium: 6.5%.

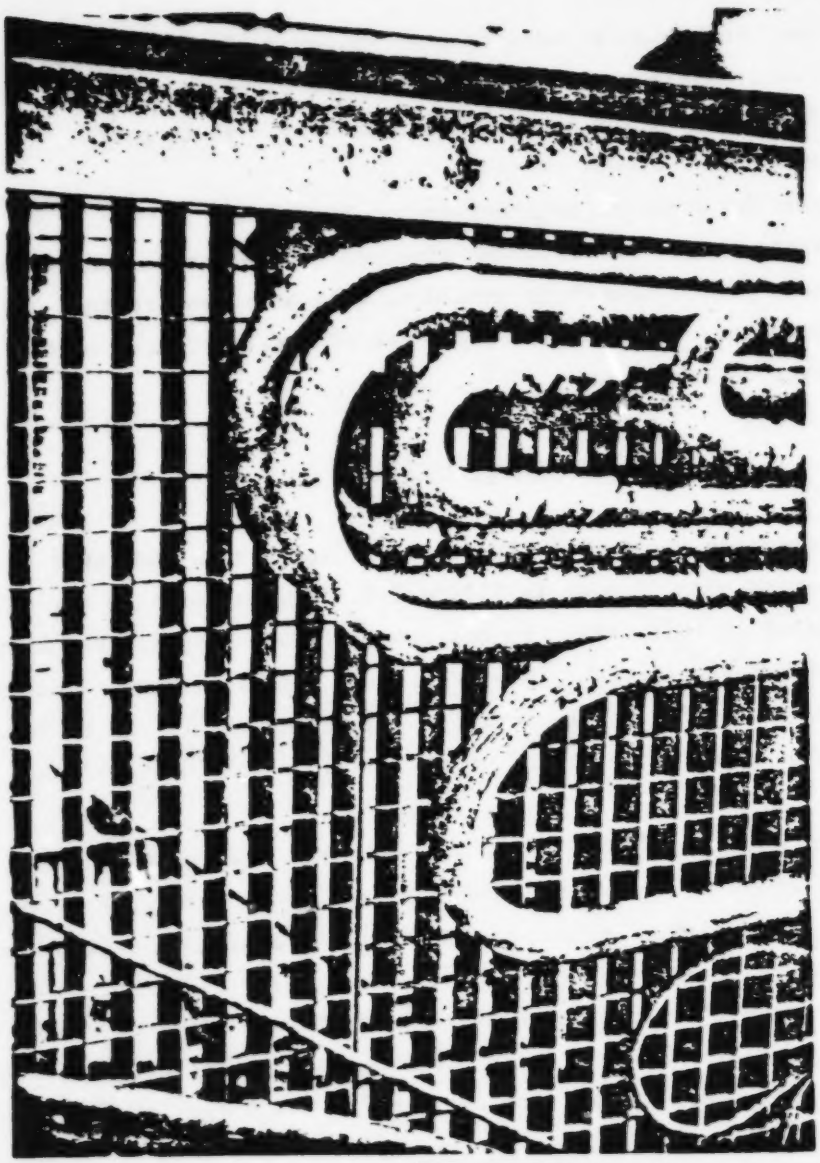
FIGURE 3-11a. HARD COATING ON BENDS OF SUPERHEATER TUBES TO BE INSTALLED IN THE SECOND PASS OF BOILER NO. 5 (Photographed on May 17, 1977)

> "For the first time after about 1,000 hours of operation time, we experienced comparatively severe corrosion on the tubes of the first stage superheater at the side of the direction of gas flow. The uppermost rows of tubes of the superheater carried, under a relatively small scale of deposits, a heavy layer of corrosion products. By the thickness of this layer, it had to be concluded that rapid wastage of these tubes could be expected. However, as operations continued, the corrosion rate declined and has reached a level which causes a barely measurable waste of material. The tubes now are covered with a hard layer of deposits."

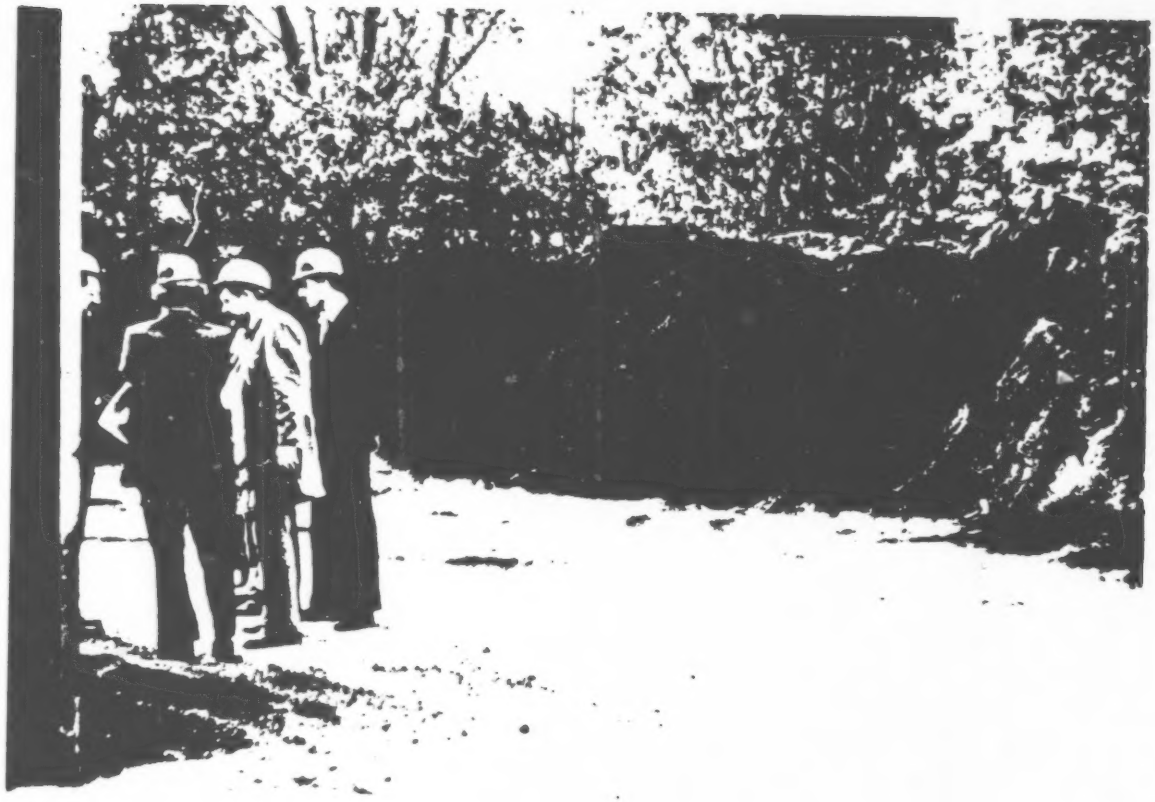
Figure 3-15 pictures Mr. Thoemen, in white helmet, answering questions of the visiting team while standing in the sized residue storage area. As shown in Table 3-10, this fines residue was sold in 1975 for an average price of 1.01 DM/tonne ($0.39/ton). The affiliated company sells a portion of the residue for 9 DM/tonne ($3.44/ton).

FIGURE 3-15. VISITORS DISCUSSING FINE ASH RESIDUE USES NEAR STORAGE AREA (Battelle Photograph)
